## Vertical lines in the display of my Kenwood TM-V7 Dual Bander

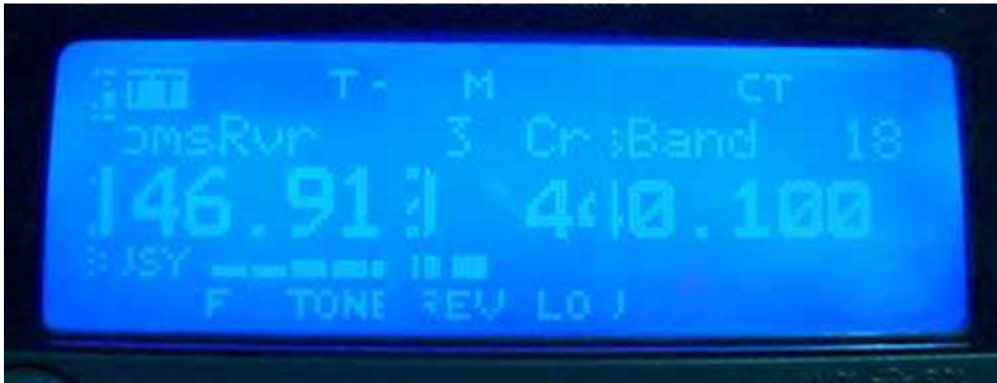
Blue background

I have had this radio for about 3 years. I bought the radio new and the lines started to appear about a year and a half after I bought it (out of warranty of course). It started out as one thin vertical line on the left side which would come and go. More lines started to appear after that and the photos above show what it looks like today. Occasionally more lines appear. The radio has not been subjected to extreme cold or heat. I've done a little research and found that this problem is *not* uncommon, I've also found out that Kenwood wants \$150 to \$200 to fix this problem (I only paid \$400 for it new). If this is a fairly common problem and is the result of a design defect it is my opinion that this should be repaired free of charge or at least at a reduced rate.

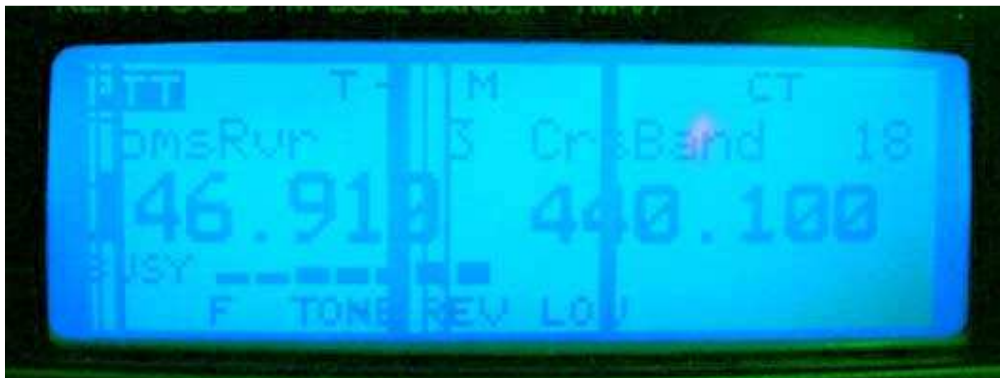
White background
